# DRAFT

## School Traffic Congestion Analysis

2023

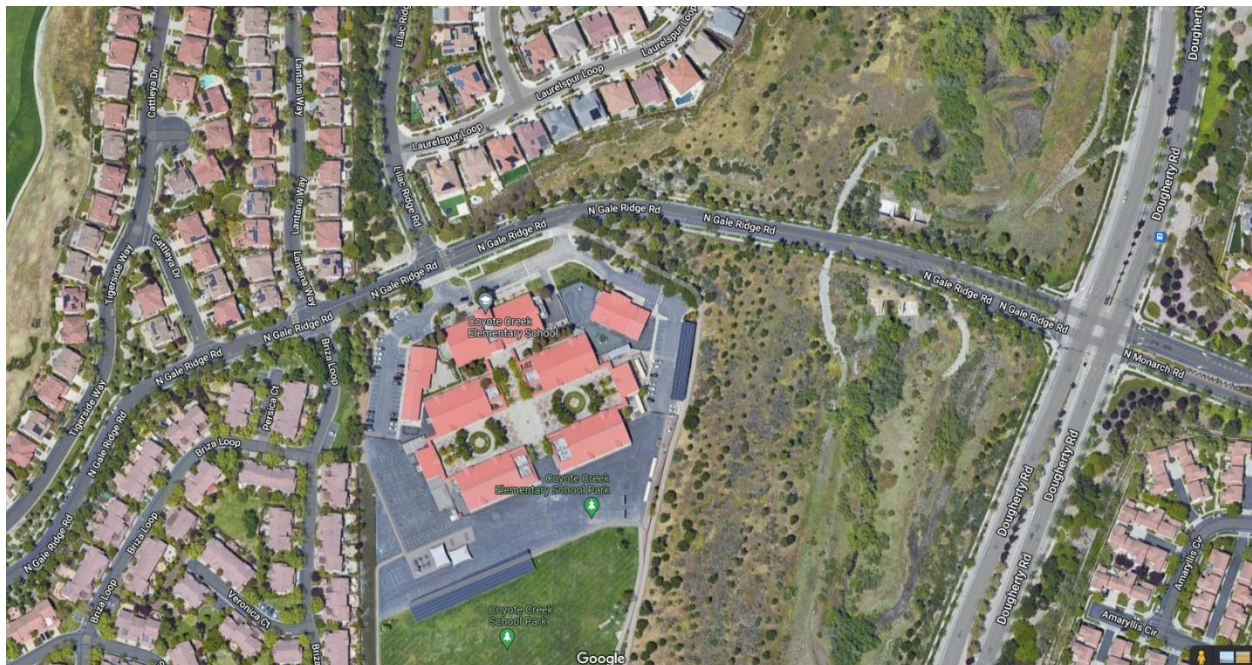
Two buses currently serve this school. The bus loading zone is the front half of the loading zone. Another potential location for bus loading is the on-street curb in front of the school, which is 160 feet and can accommodate three buses and includes a grassy area for student staging.

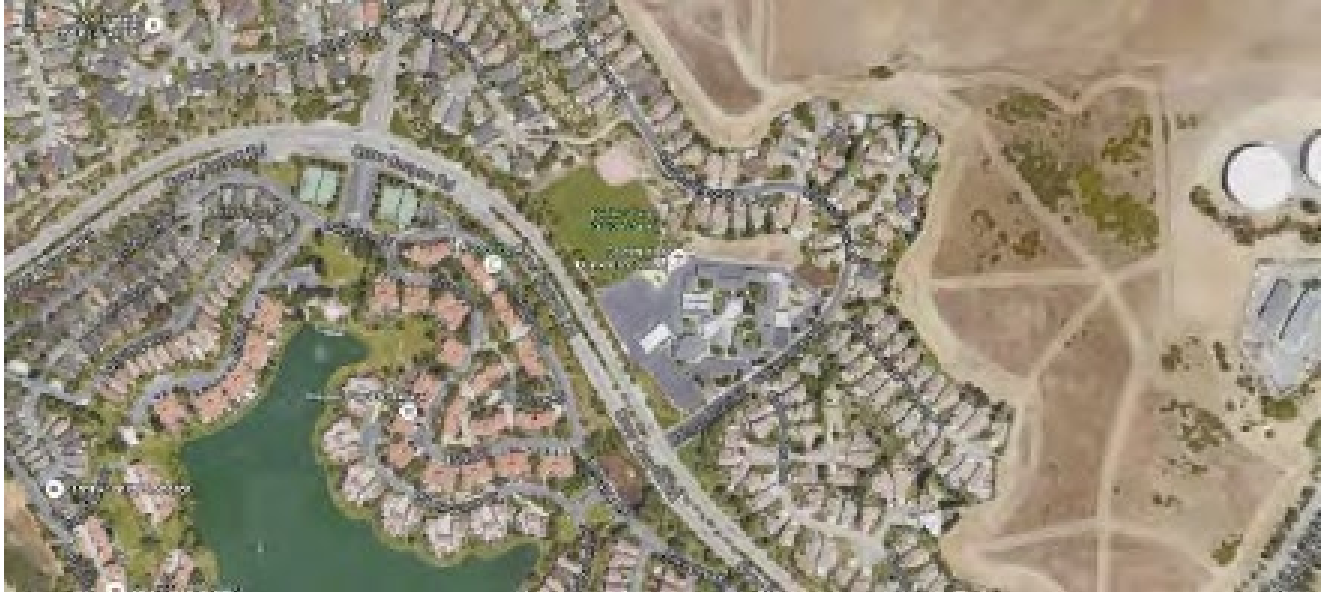
The space for a bus loading zone on-campus is limited due to tight turn radii. The recommended location for bus loading is curbside on Canyon Crest Drive, north of the main driveway entrance in the 80-foot loading zone and the 60-foot loading zone. Three to four buses can be accommodated there with lawn areas for the students to stage prior to loading.

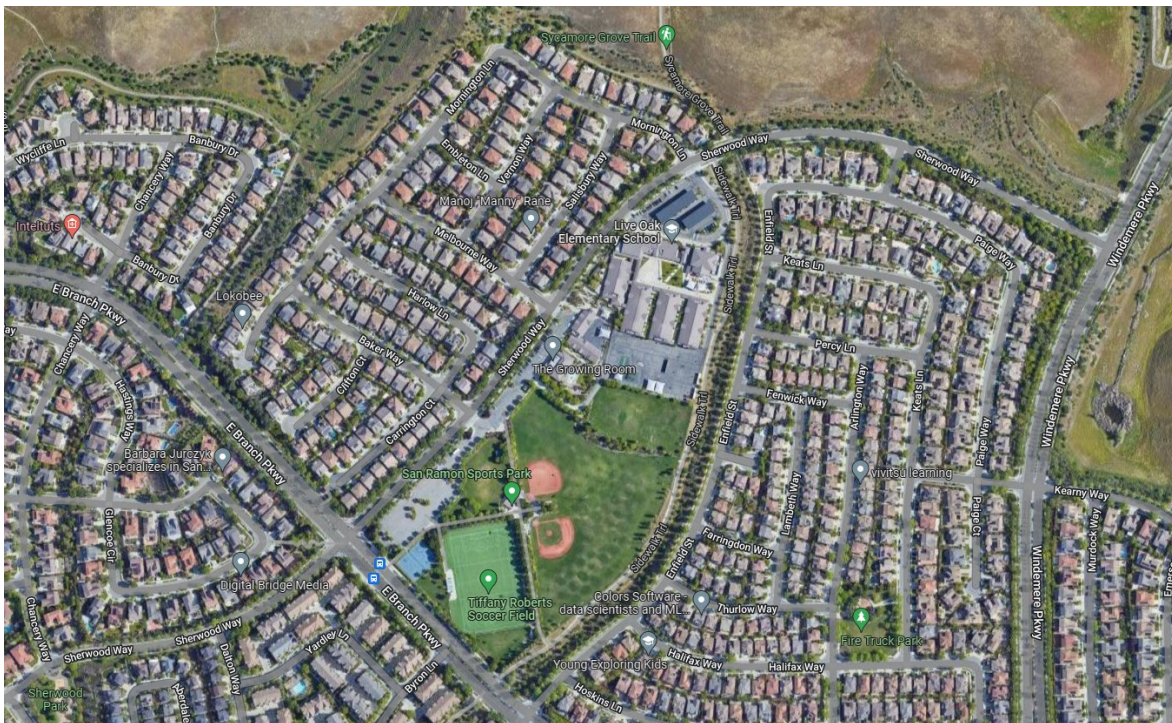
There is plenty of space to accommodate bus loading within the existing loading zone. Up to 150 feet at the end of the loading zone can be used for three buses.

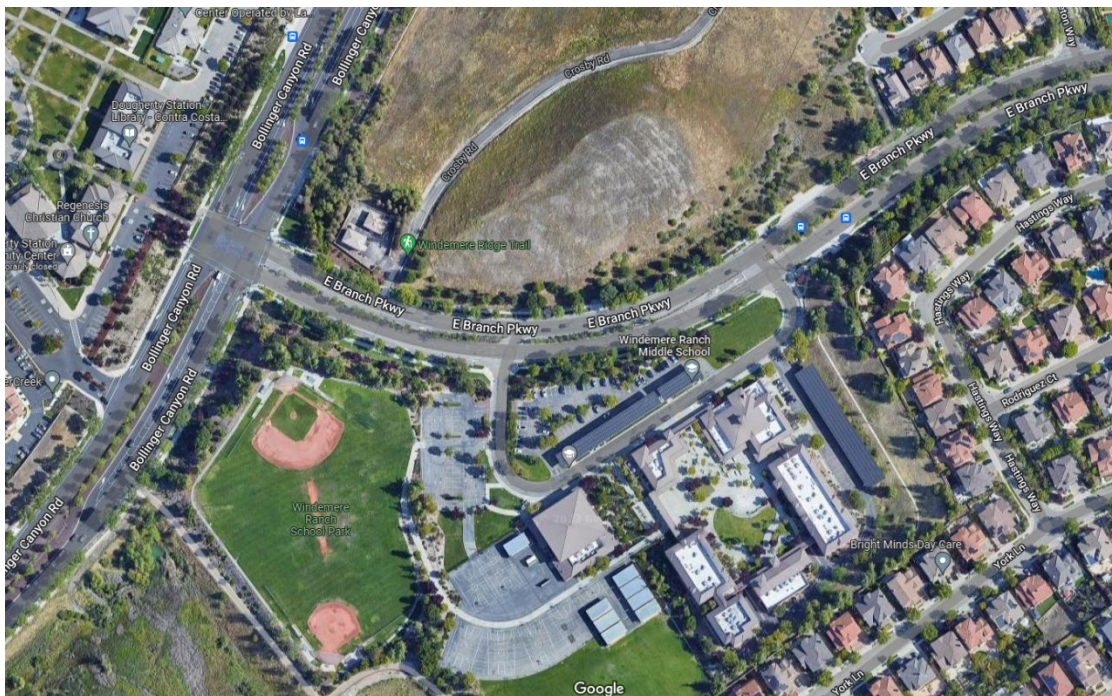
Although the loading zone can accommodate many buses, it is recommended that no more than two buses load in the red zone area at the very front of the loading zone since this curbside space is not used by the loading activity.

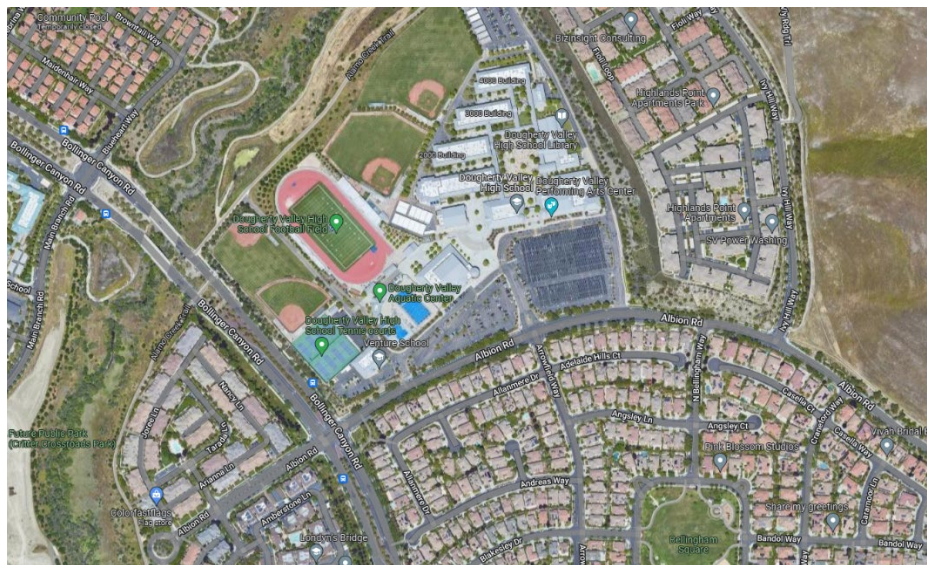
This currently does not have bus service. Although the loading zone can accommodate many buses, it is recommended that no more than two buses load in the red zone area at the very front of the loading zone since this curbside space is not used by the loading activity. Additionally, there's extra width in the curbside lane to accommodate two buses. If additional buses are required, it is recommended to remove 18 curbside parking spaces in front of the building to the west of the loading area. These 160 feet could accommodate two to three additional buses.

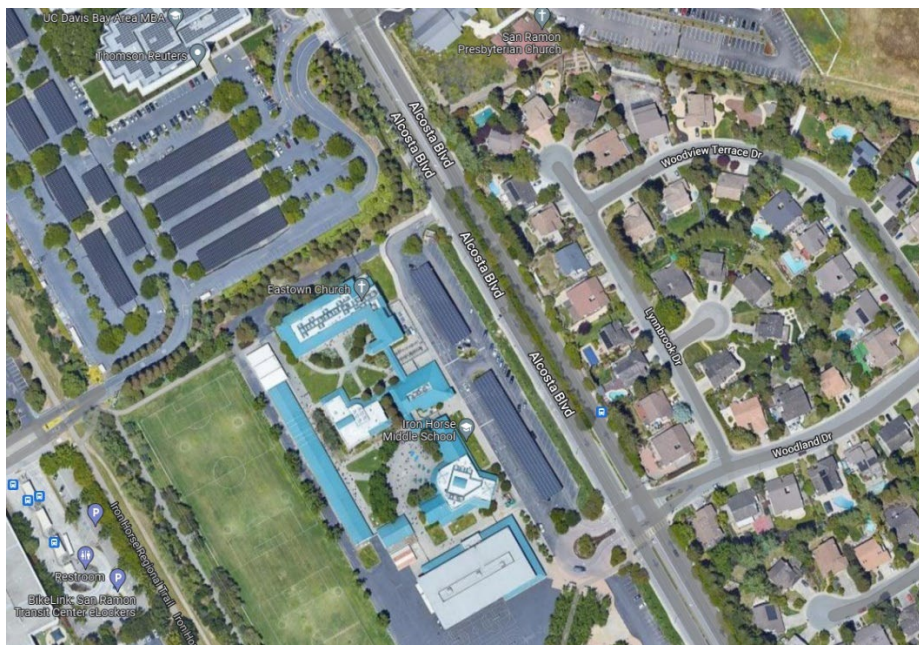
The recommended location for a bus loading zone is the front half of the loading zone as it was relatively unused for loading zone activities and the egress queue during the afternoon can back up to this area. This area encompasses the 250 feet of the loading zone closest to the egress driveway and can accommodate up to 5 buses.

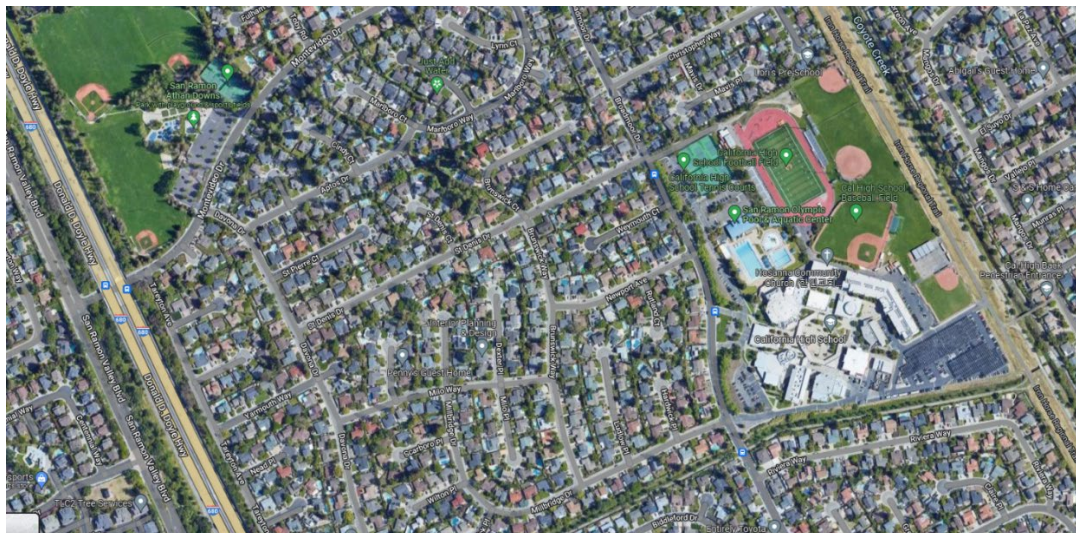
This school is currently served by one bus which loads in the red zone just south of the entrance to the circular loading zone. There is 250 feet between the ingress circular driveway and the driveway for the south loading area. This can be converted to bus loading for up to five buses.

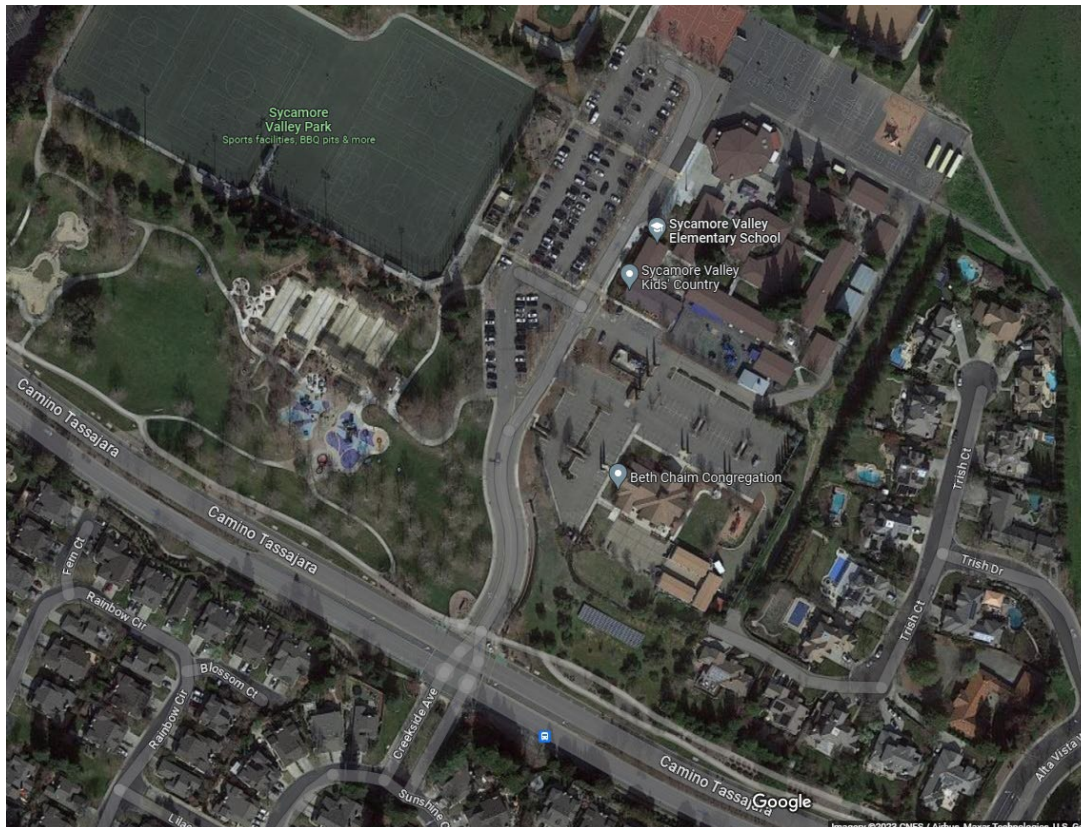
There are limited locations appropriate for a bus loading zone. It is recommended that 100 feet at the front of the loading zone can be utilized as a bus loading zone. This area is less used by vehicles since it is past the school entrance. Two buses can be accommodated at this location.

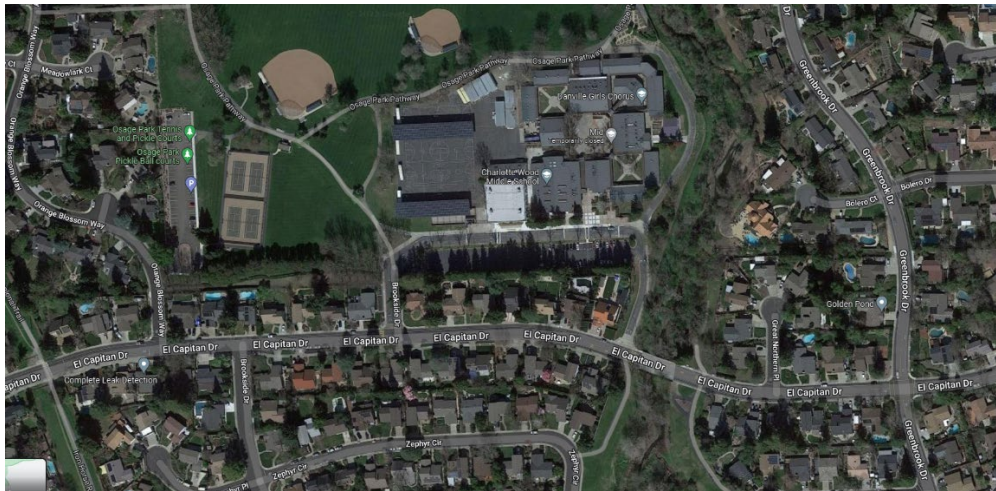
It is recommended to convert up to 200 feet of the westernmost loading zone up to the first mid-block crosswalk to accommodate up to four buses.
